Salt mist test

Results evaluation standard

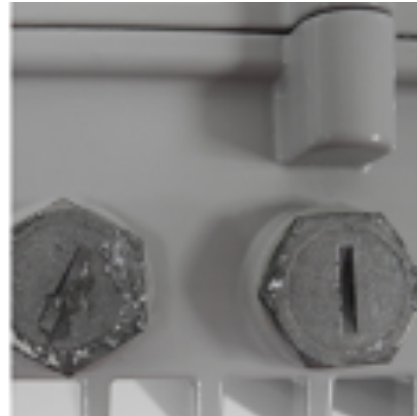
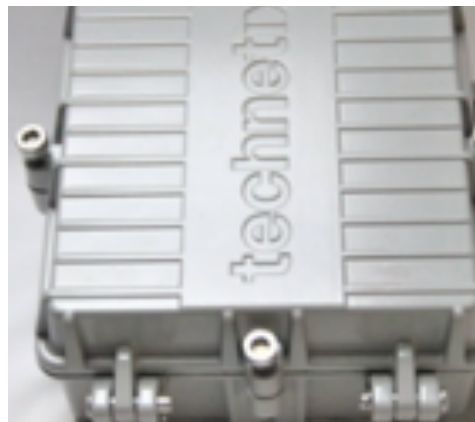
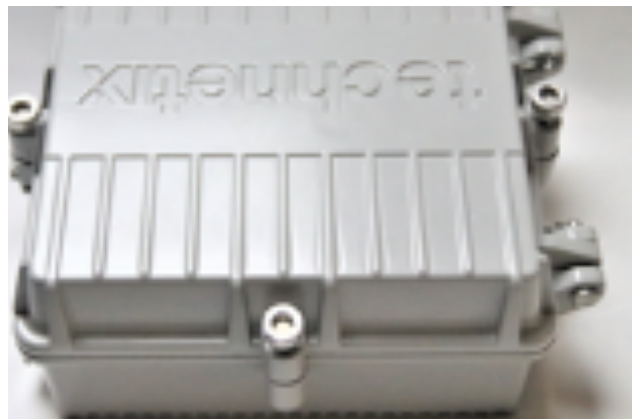
Examples of Grade 1 test samples

4.1 Grade 1: no noticeable alteration or pitting of surface, all seals intact, electrical performance within specification.

- Coating condition: no degradation/alteration of coating.

- Surface pitting: no pitting observed on the surfaces.

- Water/moisture intrusion: none.

- Electrical performance: no change or only small change on electrical performance as compared to pretest result. Device still meets electrical specification.

If the test sample meets all the above criteria it shall be considered a Grade 1 PASS.

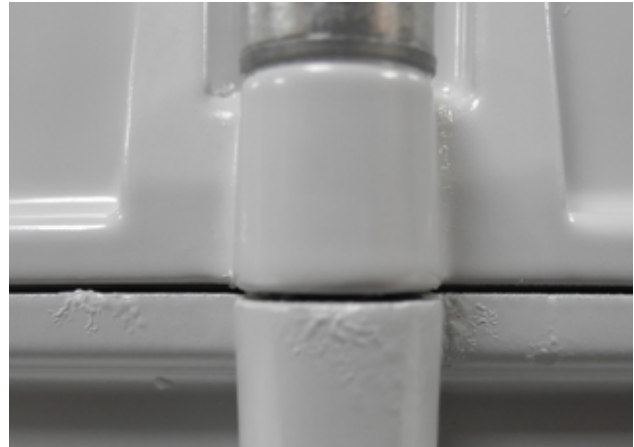
Examples of Grade 2 test samples

4.2 Grade 2: some alteration or pitting of surface exist.

- Coating condition: Some degradation, but coating not completely gone.

Some paint degradation is allowed, but not all paint completely gone.

- Surface pitting: minor pitting observed on the surfaces. Quantify the number of pitting, measure pitting depths and compare worst-case to housing's thickness.

Start of pitting (an indentation on the surface) in some areas. Less than 30% of surface area pitting is acceptable.

If the test sample meets all the above criteria it shall be considered a Grade 2 PASS.

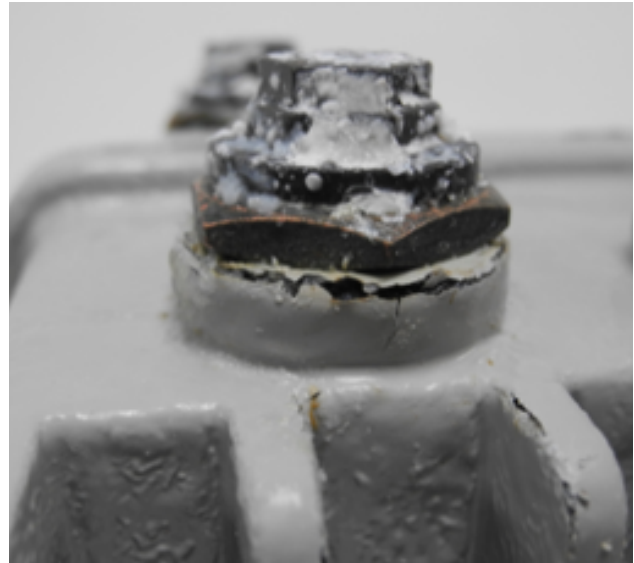
Examples of Grade 3 test sample

4.3 Grade 3: majority of surface is pitted and the majority of protective coating is adversely affected.

- Coating condition: coating is seriously depleted or completely gone.

The paint has come off the surface.

- Surface pitting: significant pitting observed on the surfaces. Surfaces can be potentially breached over time.

Pitting is in many areas of the housing covering more than 30% of surface.

- Water/moisture Intrusion: inside of device contaminated.

Water or moisture found inside the housing.
Environmental seals beached.

- Electrical Performance: significant change on electrical performance compared with pre-test results. Device does not meet electrical specification.

If the test sample meets any of the above criteria it shall be considered a Grade 3 FAILURE.
